# Blood Road Muck Mitigation Site

LRB-2019-01208

Ducks Unlimited New York In-Lieu Fee Program  
LRB-2010-00673 (ILFP)

**DATE: 23 June 2021**

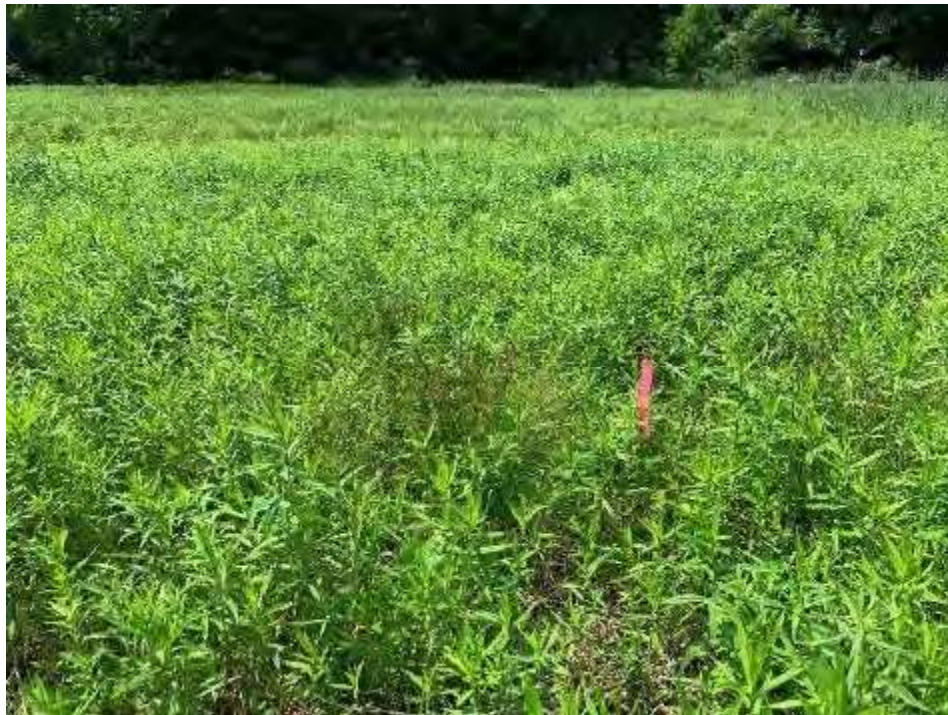
DPW5. Emergent wetland C was dominated by purplestem aster (*Symphyotrichum puniceum*) and soft rush (*Juncus effusus*). The primary hydrology indicator was saturation. A histosol was the hydric soil indicator.

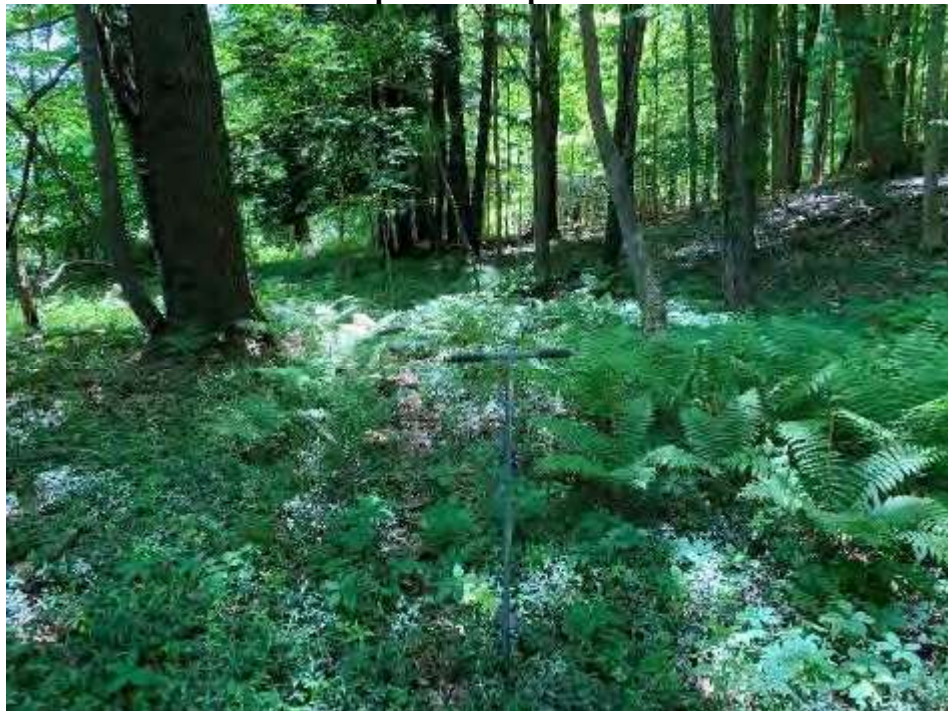
DPU1. Upland forest dominated by sugar maple (*Acer saccharum*) and eastern white pine (*Pinus strobus*), with eastern teaberry (*Gaultheria procumbens*) in the understory.

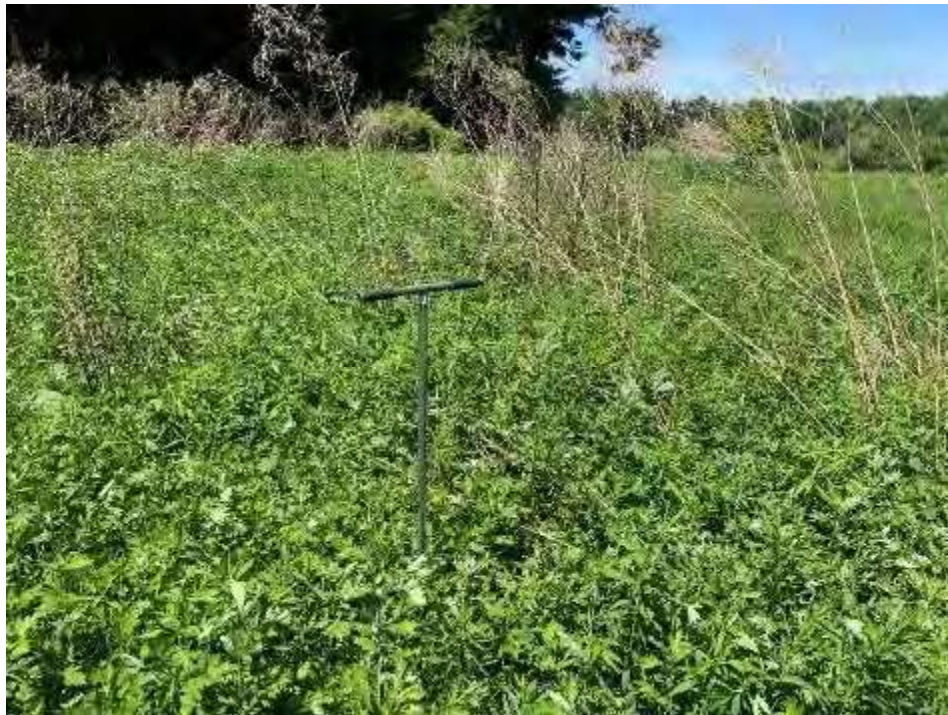
DPU2. This higher area in the southwest corner of the field was dominated by perennial ragweed (*Ambrosia psilostachya*) and Canada goldenrod (*Solidago canadensis*).

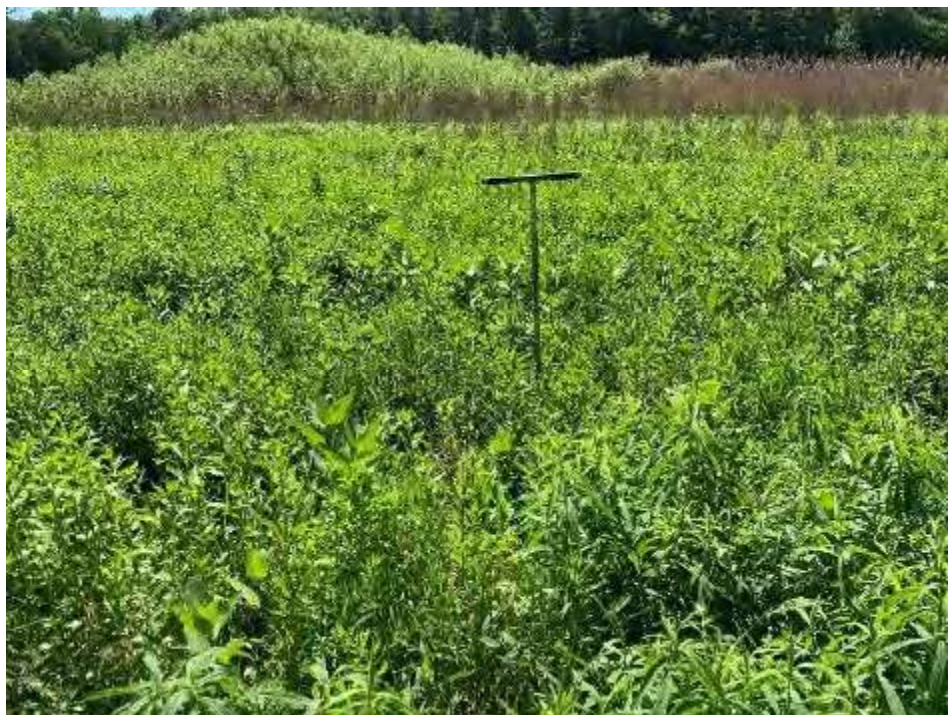
DPU3. This area was dominated by perennial ragweed (*Ambrosia psilostachya*), perennial ryegrass (*Lolium perenne*), and Canada goldenrod (*Solidago canadensis*).

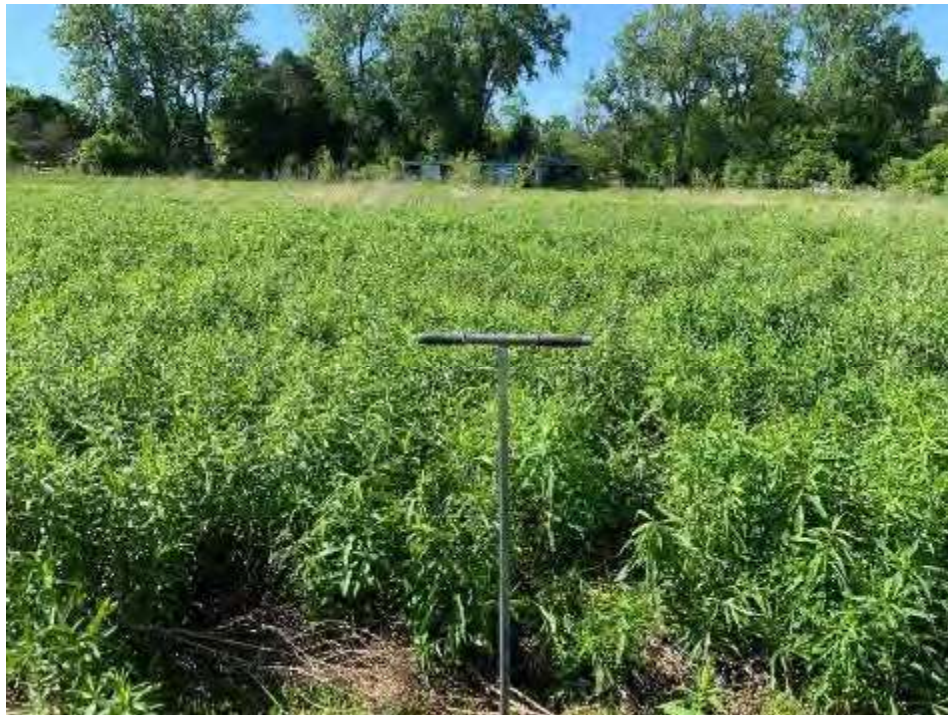
DPU4. This area was dominated by Canada goldenrod (*Solidago canadensis*).

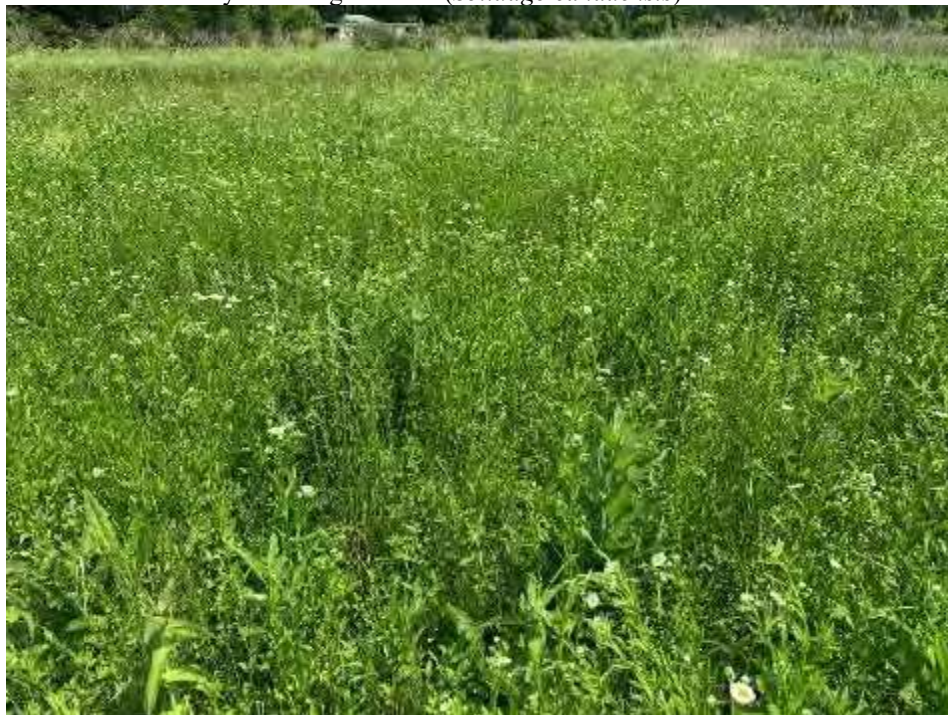
DPU5. This area was dominated by crookedstem aster (*Symphyotrichum prenanthoides*) and Canada thistle (*Cirsium arvense*).

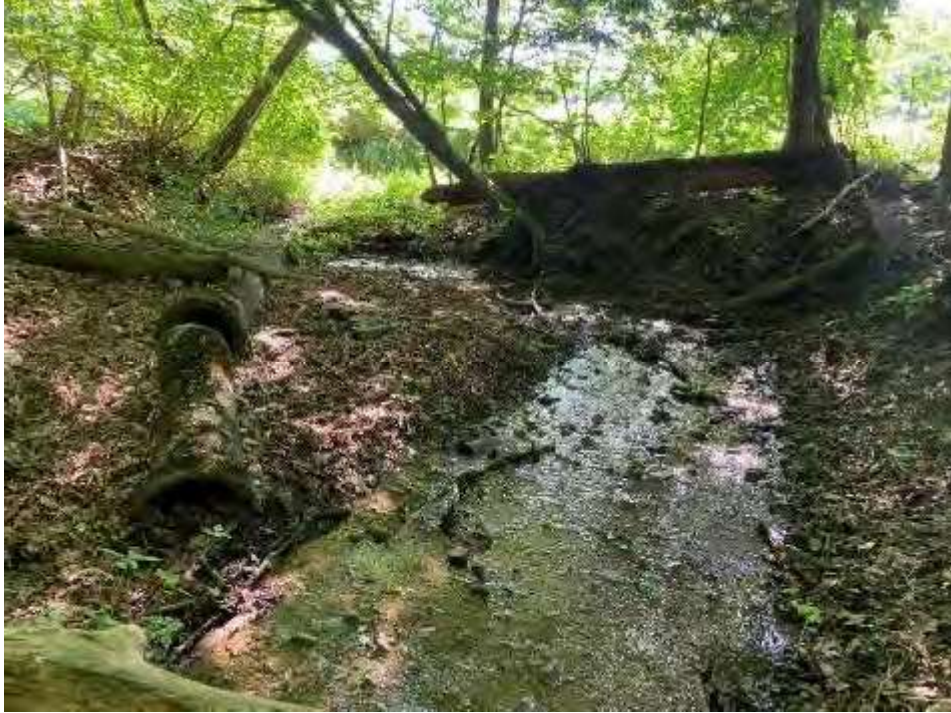
An unnamed tributary of Buffalo Creek close to where it enters the Site through the forest in the southwest corner of the property. This section is approximately 6 feet wide and 12 inches deep. Approximately 1,920 linear feet (LF) occur on the Site.

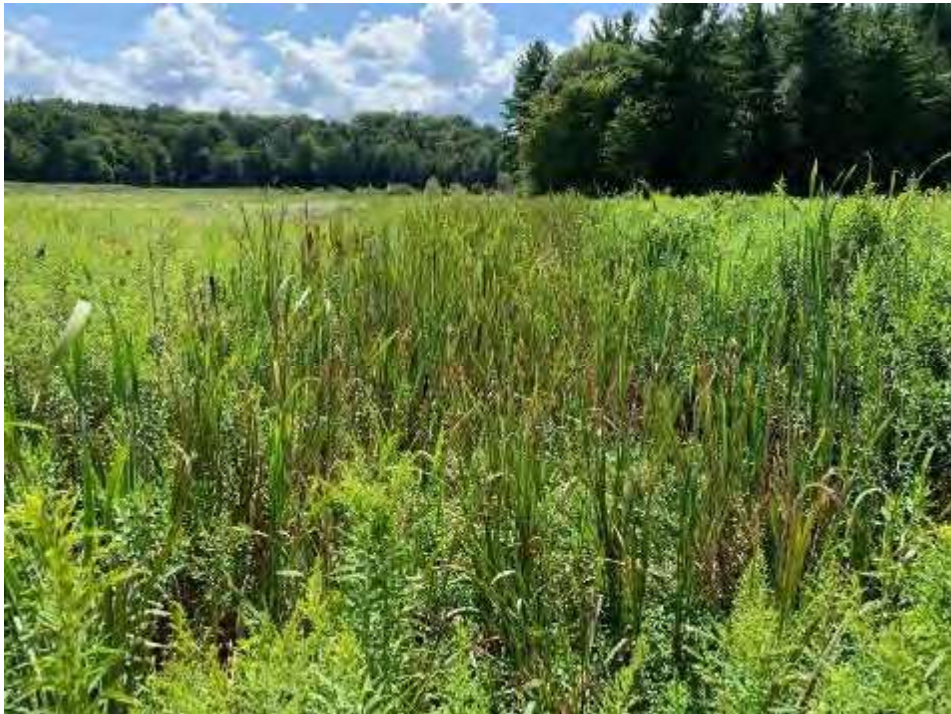
The unnamed tributary flows north, then east across the muck field. Grading activities adjacent to this stream will be above the mean high water elevation.

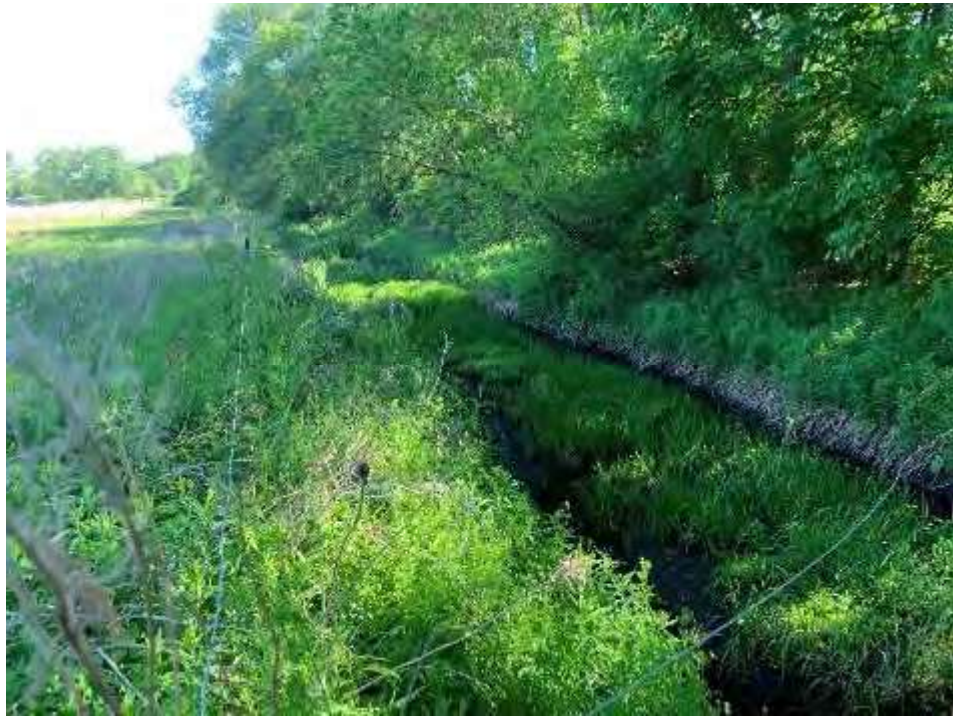
The muck fields are encircled by 3,556 LF of perimeter ditches. These ditches are approximately 8 feet wide and 12 inches deep. Construction plans include filling a portion of these ditches to allow more surface water to enter the Site.

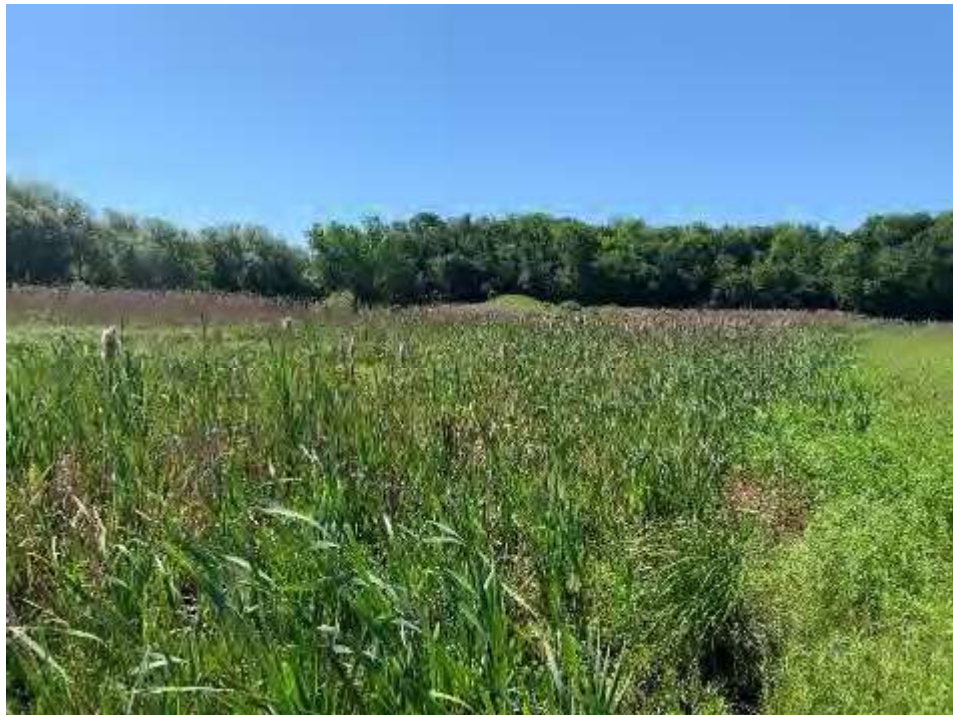
An interior drainage ditch that runs south to north through Wetland B. The ditch flows along the east side of an elevated access path before entering a culvert which carries the water to the perimeter ditch in the northeast corner of the site. Construction plans will include the disruption of this culvert.

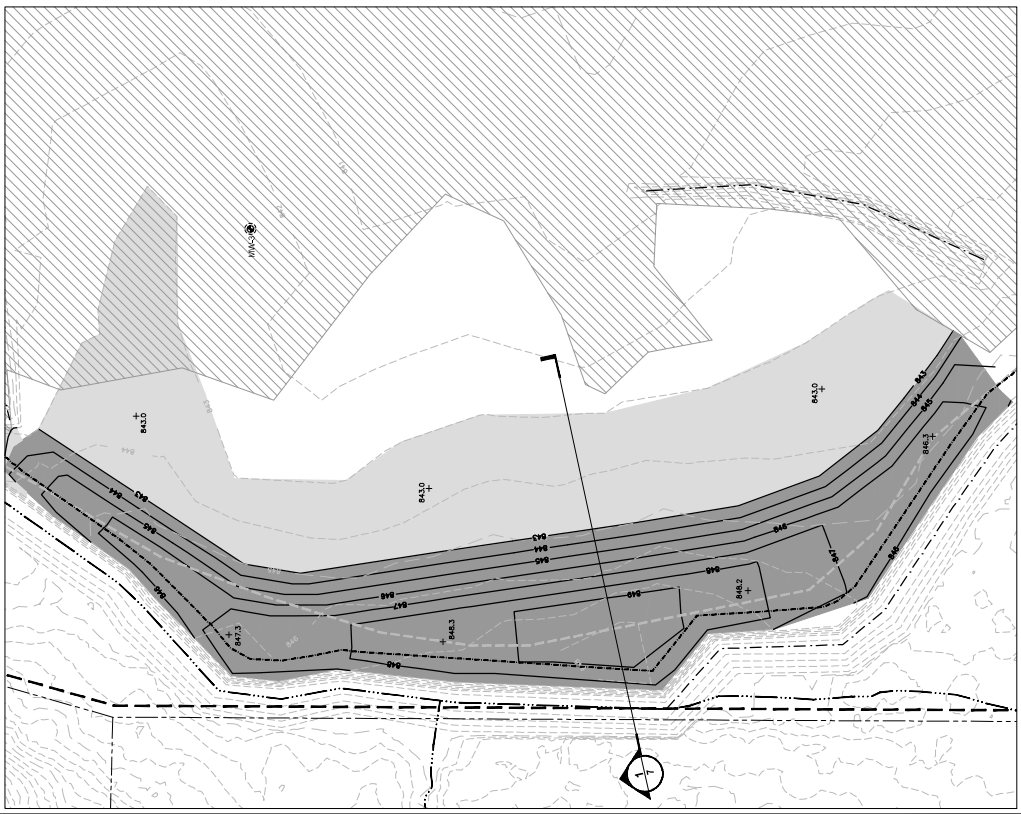
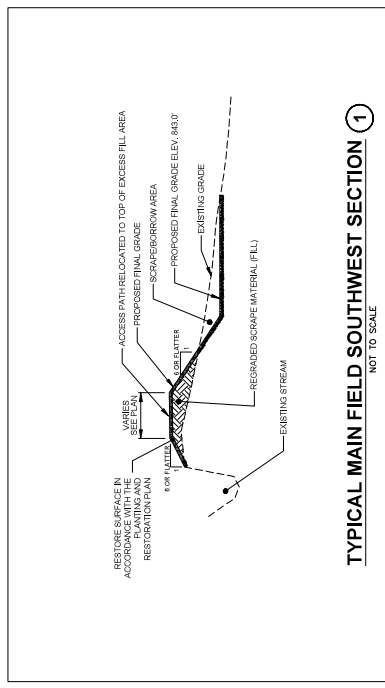
**MAIN FIELD SOUTHWEST PLAN**

- SEE DRAWING 4 FOR BASEMAP INFORMATION.
- ACCESS PATH SHALL BE RELOCATED TO THE TOP OF WETLAND RESTORATION ACTIVITIES. ACCESS PATH WILL CONSIST OF STANDARD UPLAND SEED MIX COVER AS DEPICTED ON THE RESTORATION PLAN.
